Corsica River Stream Corridor Assessment And Shoreline Surveys

Watershed Assessment and Targeting Division
Watershed Services Unit
Maryland Department of Natural Resources
August 2004

CORSICA RIVER STREAM CORRIDOR ASSESSMENT AND SHORELINE SURVEYS

Stephen Czwartacki, Ken Yetman & Anne Patterson
Watershed Assessment and Targeting Division
Watershed Services Unit
Maryland Department of Natural Resources

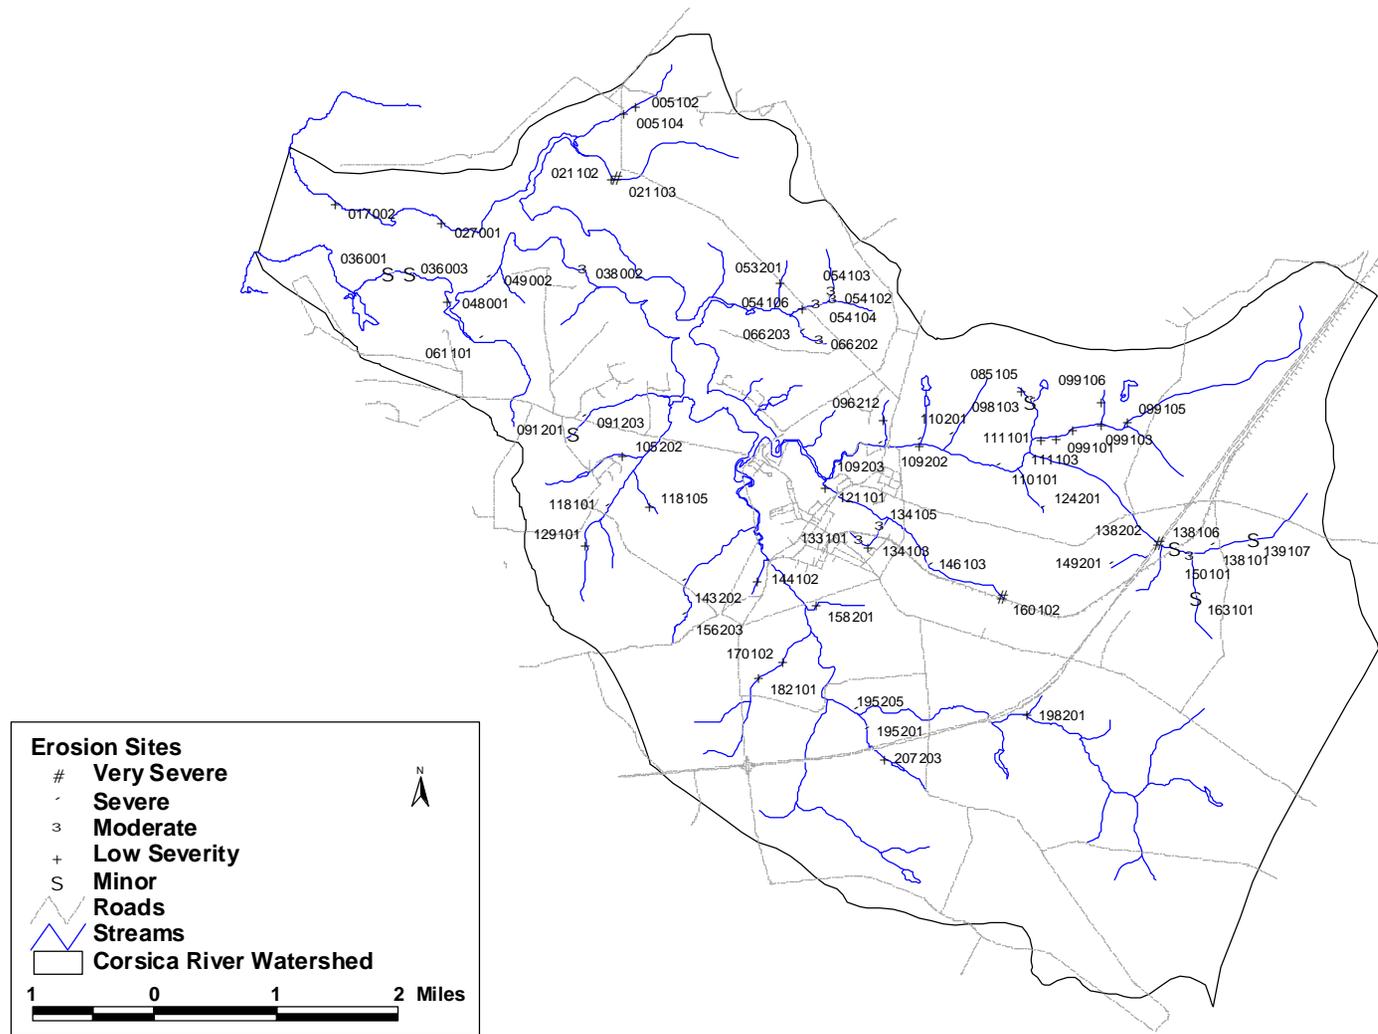
Figure 4b: Corsica River Erosion Site Locations.

The SCA survey found 57 eroding stream banks over the length of 64,312 feet (12.18 miles) of stream, or about 26% of streams surveyed. The severity and location of erosion sites is shown in Figure 4b. Three sites are ranked as very severe, 17 as of severe, 7 as moderate, 25 as low severity, and 5 as minor (Figure 4a). Length of these sites varies from 15 to 7,230 feet. Heights of the stream banks at erosion sites in the Corsica River watershed vary from 1 to 12 feet (Appendix B).

Three sites were found to be very severe. Site 021103 is on the south tributary to Emory Creek, and was identified as widening erosion site. The erosion problem extends for 1,037 feet, average bank height was 4 feet, and is surrounded by forest. Site 138202 is located on the south fork of the Three Bridges Branch, and is possibly being caused by an altered channel upstream. This site stretches for 7,230 feet, with average stream bank height of 4 feet and is surrounded by forest. Site 160102 is on the headwaters of Gravel Run and is found below a railroad crossing. This site is 3,430ft. long with 4 feet high banks and a crop field on the right and forest on the left. Seventeen additional sites were identified as severe (Figure 4a) and information on them is presented in Appendix A & B.

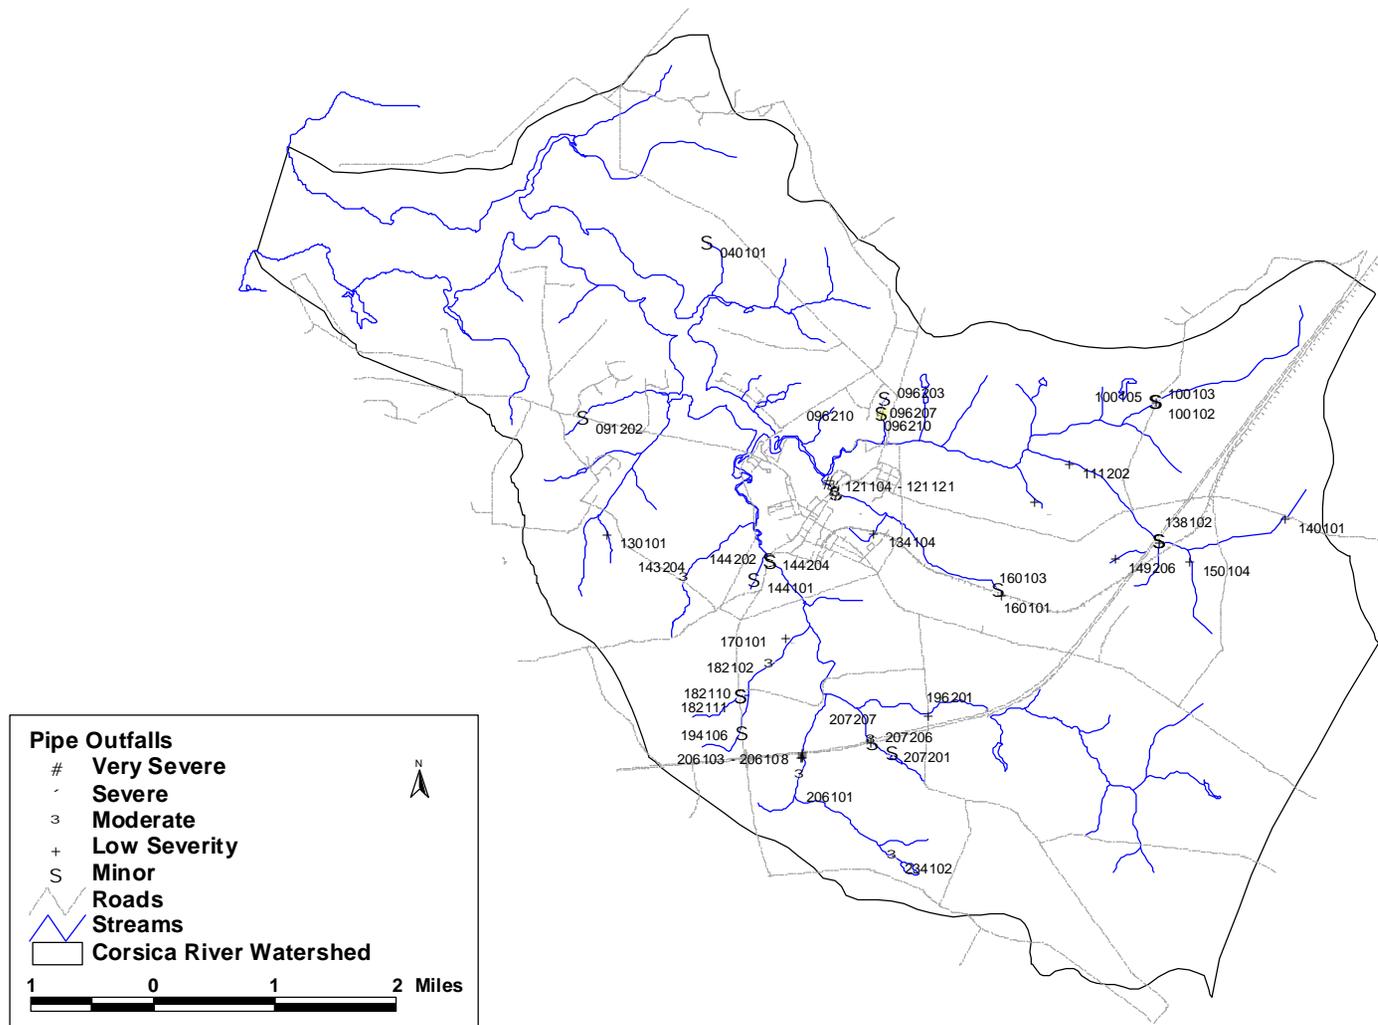
Figure 5b: Corsica River Pipe Outfall Locations.

Three pipes were rated very severe and one severe. Site 096211 is a very severely rated plastic 6in. pipe on the right bank of a tributary of Three Bridges Branch. This pipe has created a channel 2ft. wide, and has a medium brown discharge. The purpose for the pipe is unknown. Site 121104 is a 12-inch smooth metal sewage overflow pipe on the left bank of Gravel Run. Although no discharge was observed the field crew did see debris caught under the clapper valve and believed that the pipe could have recently discharged. The pipe outfall was given a very severe rating. Site 121106 is an 18 inch 4 feet long corrugated metal stormwater pipe located on the left bank of Gravel Run. A medium brown musky smelling discharged was observed, and the site was given a very severe rating. Site 121110 is a 4-inch pipe with a medium brown discharge on Gravel Run. This site was given a severe rating.

No immediate follow up actions were taken as part of this study to determine the source of the color coming from the pipe. In some cases, coloration from a storm drainpipe may be a sporadic occurrence; this is especially true in areas where no stormwater management system is present. In addition, we made no estimate of the amount of fluid released from the pipes.

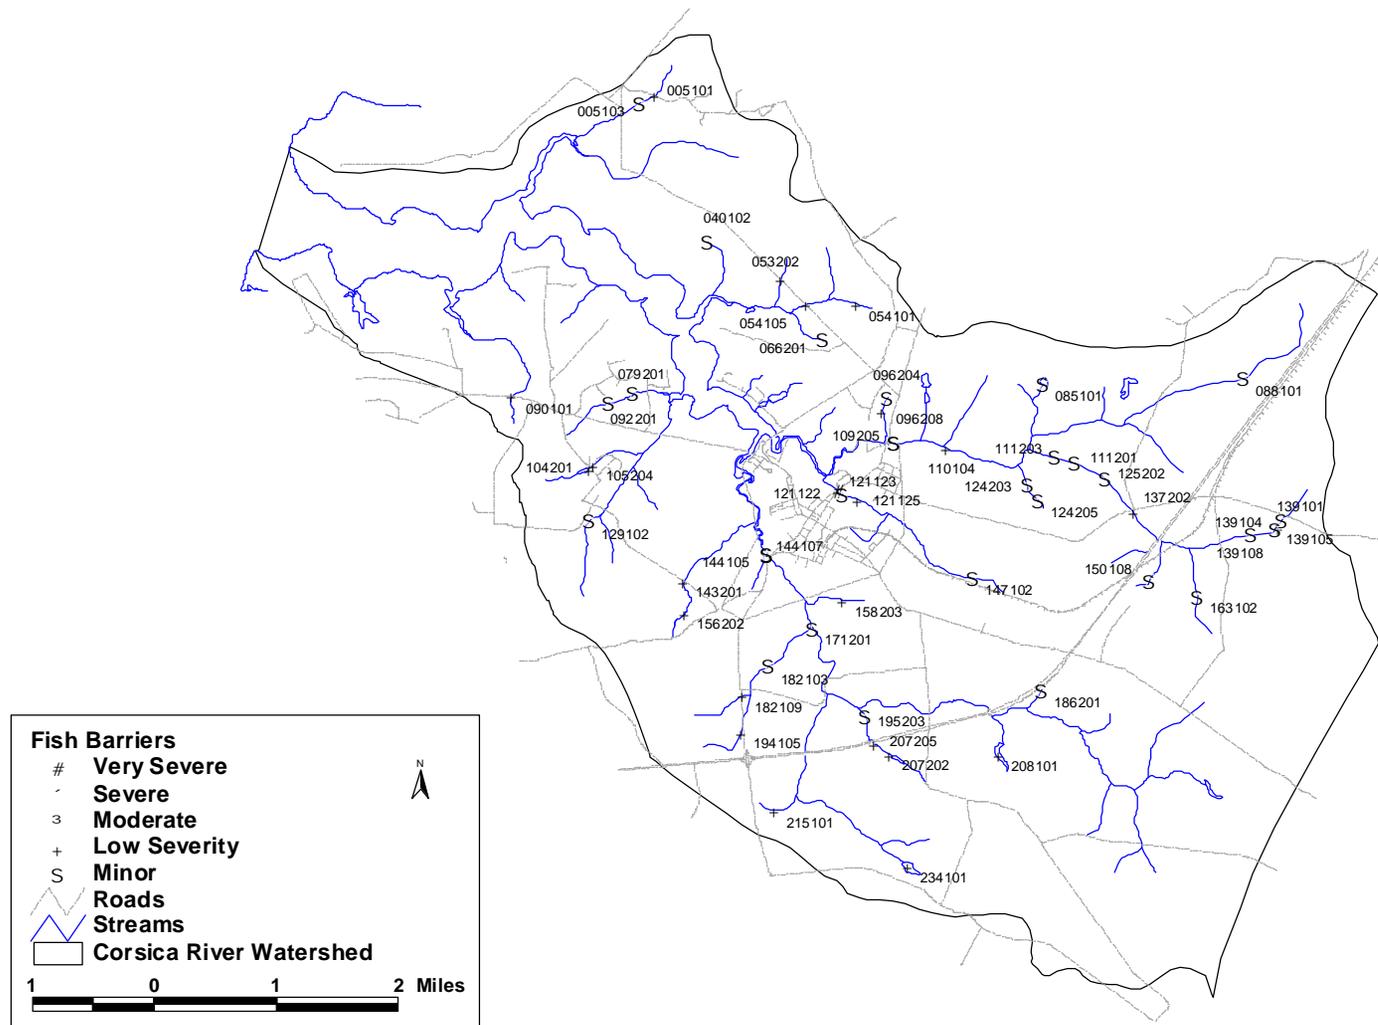
Figure 6b: Corsica River Fish Barrier Locations.

The Corsica River SCA survey found 52 fish migration barriers. The locations of fish blockages are shown in Figure 6a. Fish barriers in these watersheds are due to natural falls (24 sites), road crossings (11 sites), beaver dams (5 sites), pipe crossings (3 sites), channelized streams (1 site), and a dam. The majority of fish migration barriers (51 out of 52) are low to minor in severity (Figure 6a). These sites were given low severity rankings because they are either temporary blockages, or they isolate only a short section of stream. Site 121122 is a dam on Gravel Run with a drop of 60in. at the extent of the tidal area. This dam may impede the movement of anadromous fish in the tributary. This site is located on public land and is a potential fish passage project site.

In all cases, areas should be assessed for viable fish habitat before restoration work begins, giving preference to sites with the most potential habitat area created.

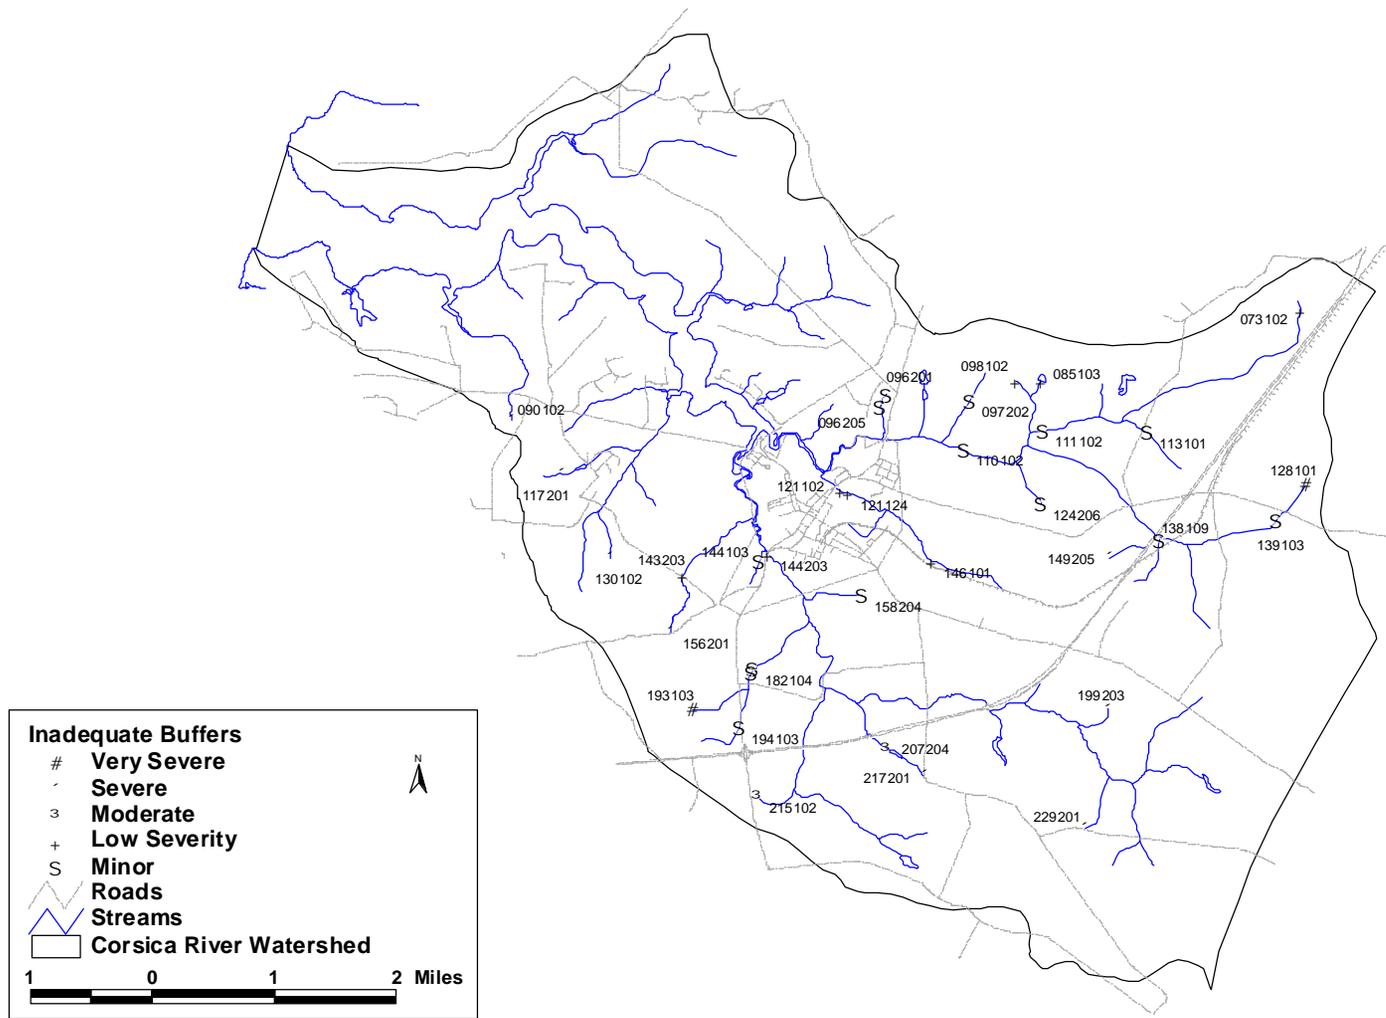
Figure 7b: Corsica River Inadequate Buffer Locations.

Survey crews identified 34 inadequate buffer sites with a total length of 20,915ft. (3.96 miles), or approximately 8% of streams surveyed. The severity and location of inadequate buffer sites is shown in Figure 7a. Twenty-four of these sites are ranked as moderate to minor severity, while the other ten sites are very severe and severe (Figure 7b). Lengths of inadequately buffered streams ranged from 70ft. to 2,165ft. Six of the 34 sites did not have a forest buffer on either side of the stream. Land use along the stream at inadequate buffer sites is recorded for both sides of the stream; therefore the land use amounts will be double the site amounts. Examples of land use for the sides of streams are as follows: cropland (39 sites), forest (9 sites), lawn (9 sites), pasture (5 sites), shrubs and small trees (4 sites), railroad tracks (1 site), and a construction site (1 site). Site 085103 had a recent buffer planting along the stream on a tributary of Three Bridges Branch. Crews reported that horses had access to the stream at site 215102.

Site 128101 is a very severe site with no buffer width stretching for 1,615ft. through a crop field on the headwaters of Three Bridges Branch. Site 193103 is also a very severe site with no buffer width for 1,575ft. through a crop field on the headwaters of Mill Stream Branch. Eight sites were given severe ratings and include: Sites 156201, 199203, 217201, and 229201 on Mill Stream Branch; Sites 117201, and 130102 on Earle Creek; Site 090102 on Middle Quarter Creek; and Site 149205 on Three Bridges Branch.

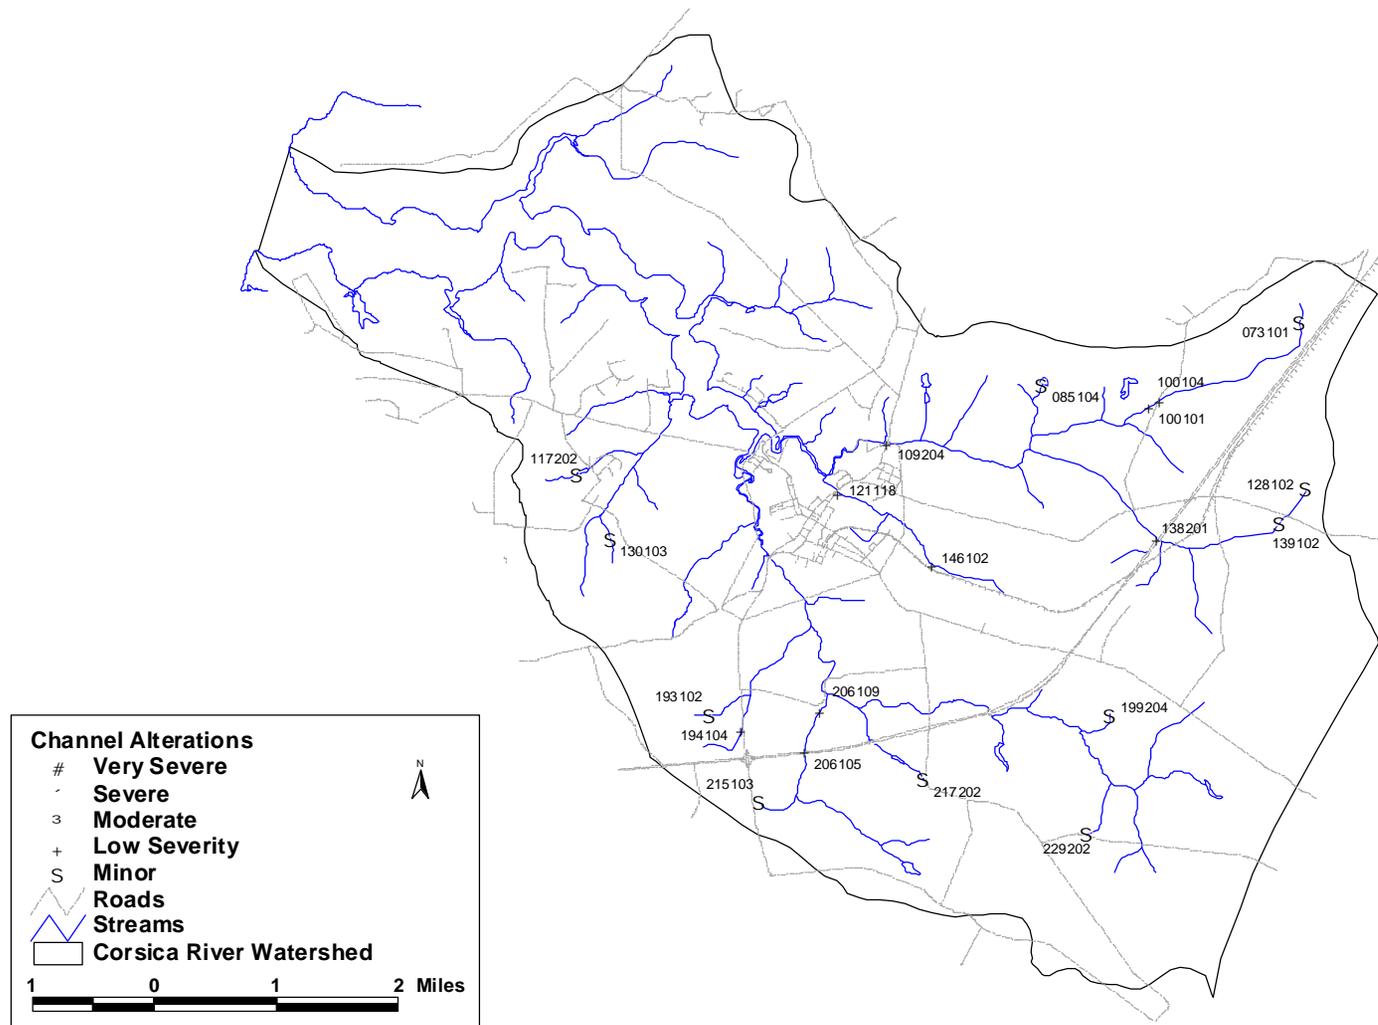
Figure 8b: Corsica River Channel Alteration Locations.

Results of this survey show recognizably altered stream channels at 20 sites. The severity and location of channel alteration sites is shown in Figure 8a. The total length of stream affected by channelization is estimated to be 6,185 feet (1.17 miles), or 2.41% of streams surveyed. All channel alteration sites were ranked low (9 sites) to minor (11 sites) in severity. The majority of sites (11 sites) were documented as earth channels. Also found were concrete channels (4 sites), rip-rap (2 sites), corrugated pipe (1 site), gabion baskets (1 site), and a metal pipe channel. Eight sites were found at road crossings. Bottom width ranged from 1.5ft. to 12ft., and length of the sites ranged from 5ft. to 1,000ft.

Survey crews documented the presence of sedimentation and vegetation in the channelized segments of streams. The presence of sedimentation and vegetation in a channel shows that the stream system is reverting back to a natural system. Fourteen out of 20 channel alteration sites were found with sedimentation in the channel, while 11 sites were documented as having vegetation in the channel. Eight sites were found with both sedimentation and vegetation. Eight channel alterations were found on Mill Stream Branch, as well as 8 on Three Bridges Branch. Two sites were reported on both Gravel Run and Earle Creek.

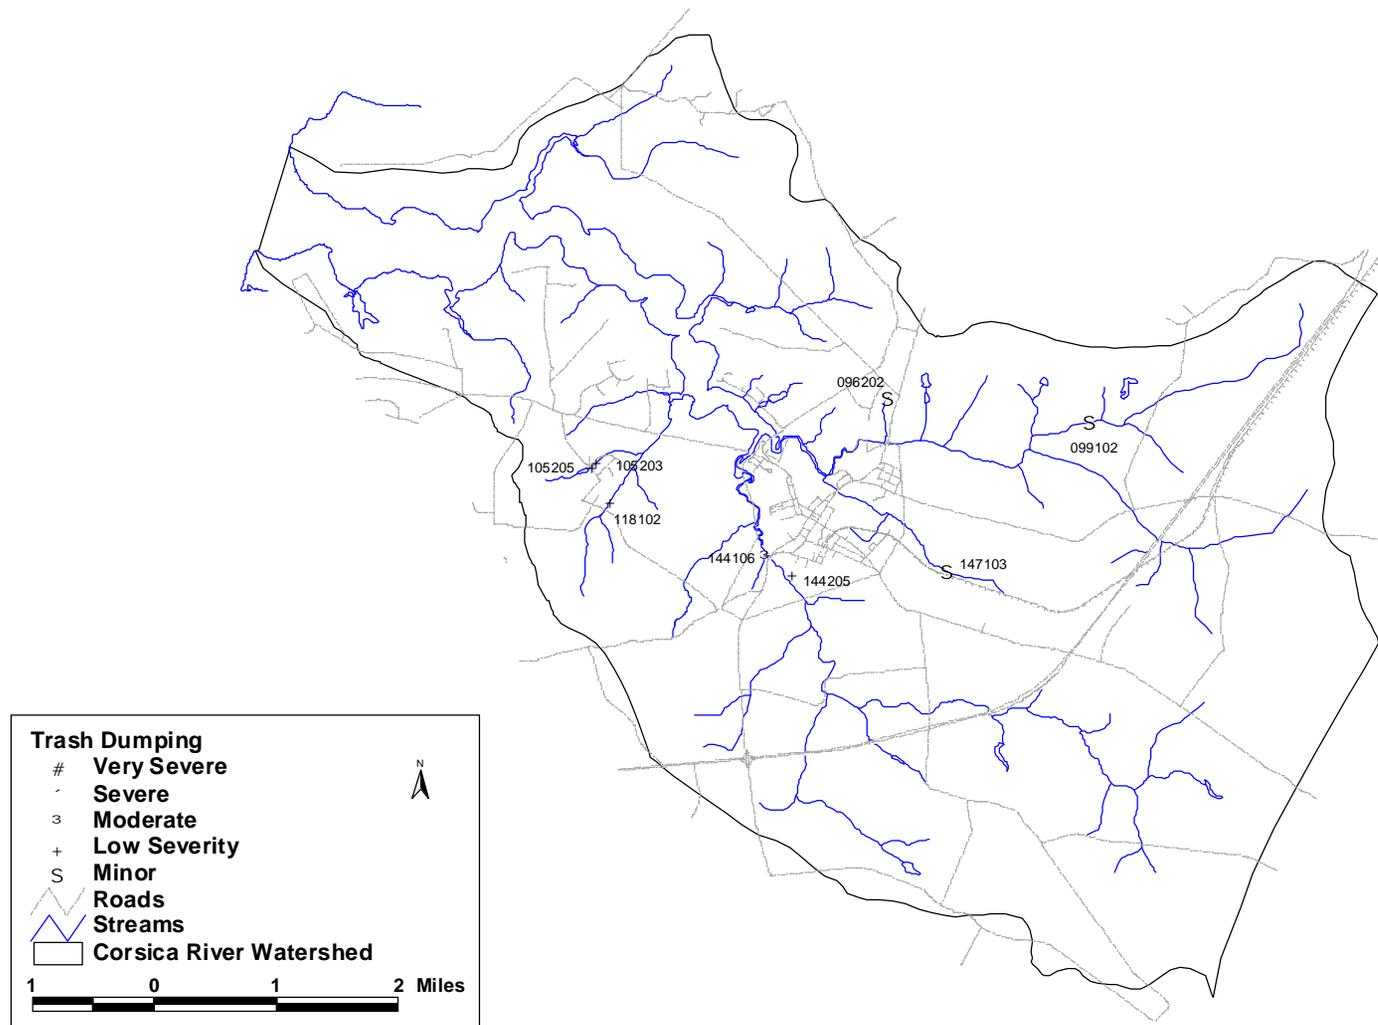
Figure 9b: Corsica River Trash Dumping Locations.

Survey crews found 8 trash dumping sites (Figure 9a). This is a very low number of sites compared to other watersheds previously surveyed throughout Maryland. In terms of severity rating, 1 sites were ranked as moderate, 4 were given a low severity rating, and 3 were considered minor (Figure 9b). Two sites contained residential waste, 3 sites had construction materials and lumber, 1 site had industrial material, 1 site had tires and one site was characterized as junkyard of cars and buses. The one moderate site (144106) consisted of a junkyard of cars and buses over a larger area within the stream corridor behind a residence on Mill Stream Branch. Site 096202 at a construction site on Three Bridges Branch, was the only other site considered a large area. All other sites were located at confined sites, and 5 sites, 096202, 099102, 105203, 118102, and 147103 are potential sites for volunteer clean-up projects. Ownership of lands containing the trash dumping sites were either private (5 sites) or unknown (3 sites).

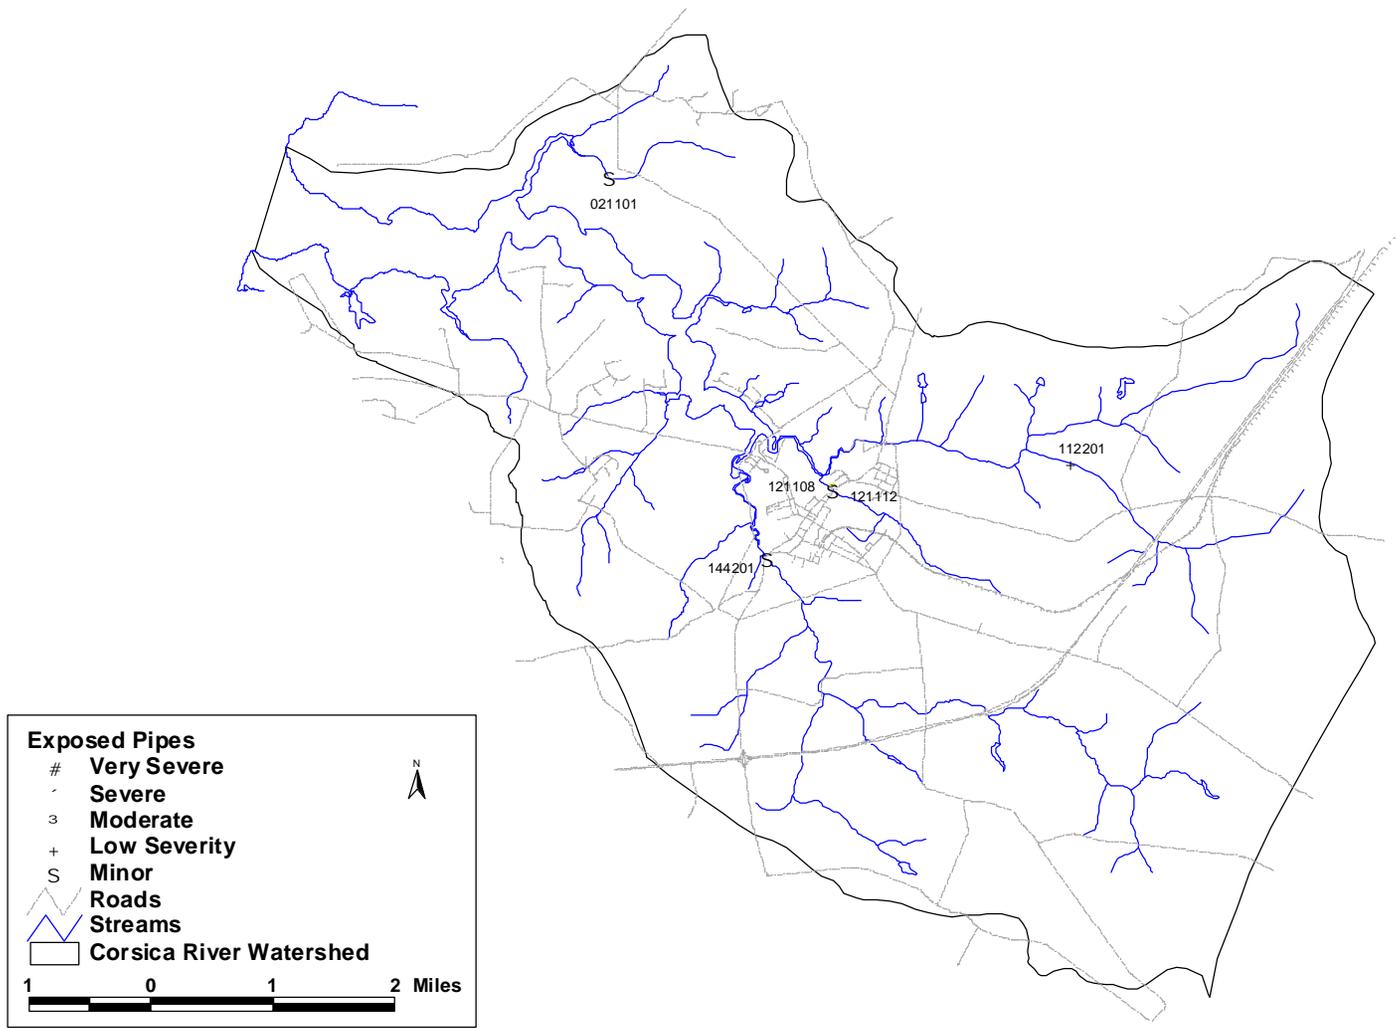
Figure 10b: Corsica River Pipe Outfall Locations

Field crews observed 5 exposed pipes during the survey. One of these sites received a severe rating while the others were given low severity (1 site) or minor (3 site) ratings (Figure 10a). Figure 10b shows the location of these sites. Two pipes were exposed across the bottom of the stream, 2 were exposed along the stream bank, and 1 pipe was exposed below a bridge. Three pipes were documented as smooth metal pipes, 1 as a plastic pipe, and 1 as a concrete sewage pipe. Pipe diameters ranged from 2 to 36 inches, and the lengths of the exposed pipes ranged from 8 to 300 feet. None of the observed pipes had a discharge, and all but one sewage pipe were unknown in origin. Site 121108 is the only severe pipe to be documented. This site is a pipe 36in. in diameter concrete sewage pipe exposed across the bottom of the stream below the Rte. 213 bridge on Gravel Run. Follow-up visits could be made to the sites to further evaluate their severities and a means for repairing or replacing the pipes.

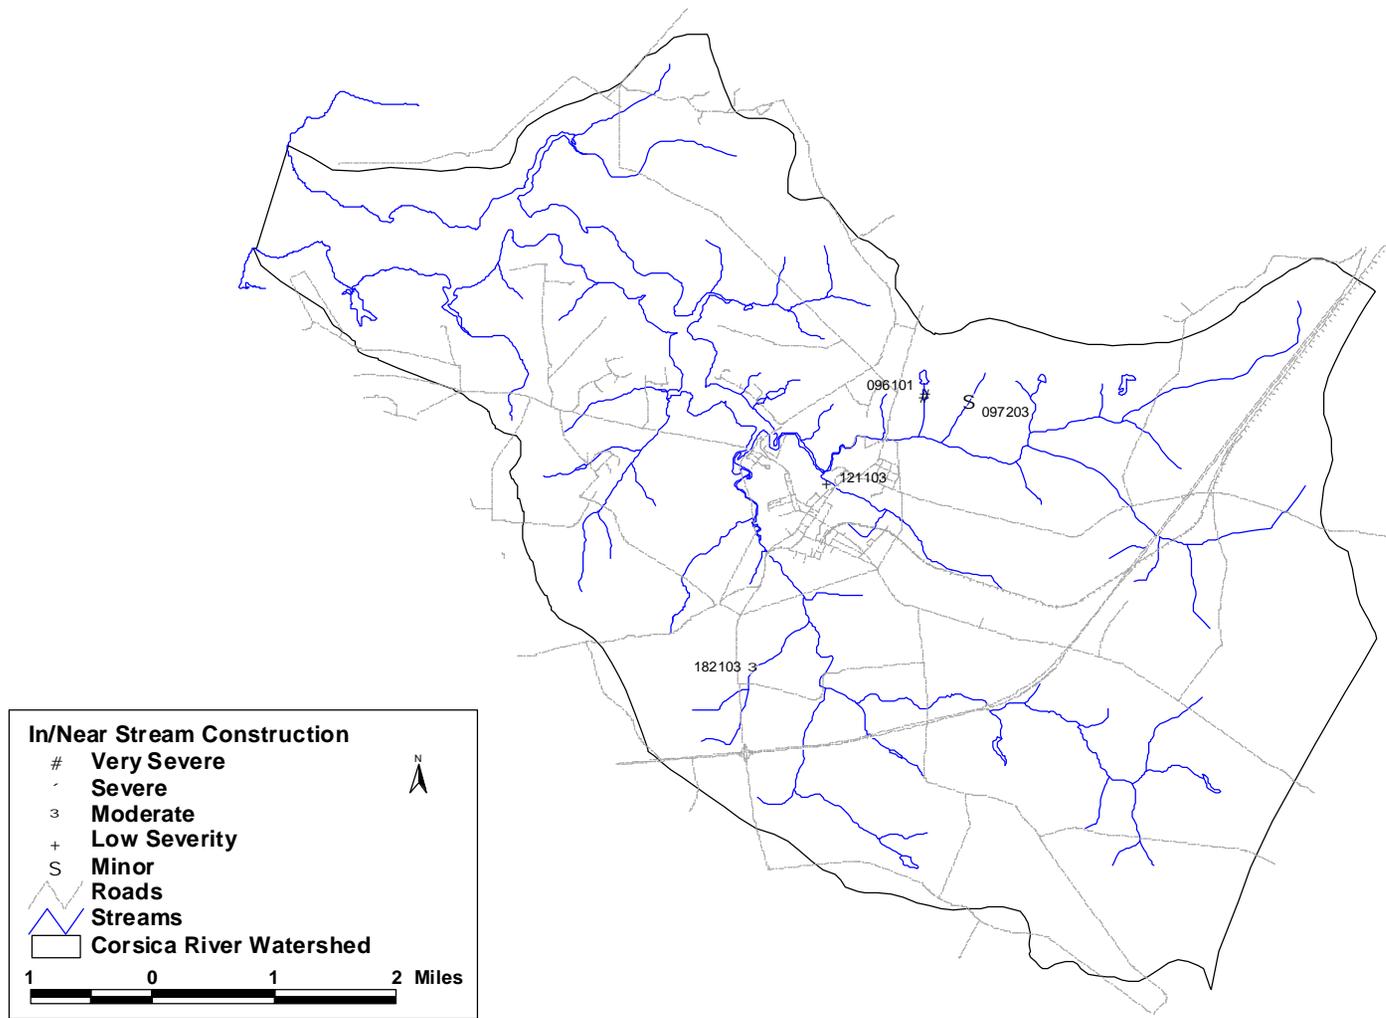
Figure 11b: Corsica River Pipe Outfall Locations

In or near stream construction was reported at 4 sites during the Corsica River survey. Two sites were found on tributaries of Three Bridges Branch, 1 site was observed on Gravel Run and one was observed on Mill Stream Branch. Three sites were involving residential development, and one was involving logging. Three sites were found to have adequate sediment control, while one (site 182105) did not. Two sites had excess sediment in the stream. Lengths of sites ranged from 150ft. to 1800ft. The locations of in/near stream construction sites are shown in Figure 11b.

Most sites were given a low to minor severity rating (Figure 11a). One site (096101) was given a severe rating. The site is located at a new residential development site at the head of a tributary on Three Bridges Branch. Field crews reported what appeared to be excess sediment in the stream channel downstream of the new development. The town of Centreville was notified about this site shortly after it was observed.

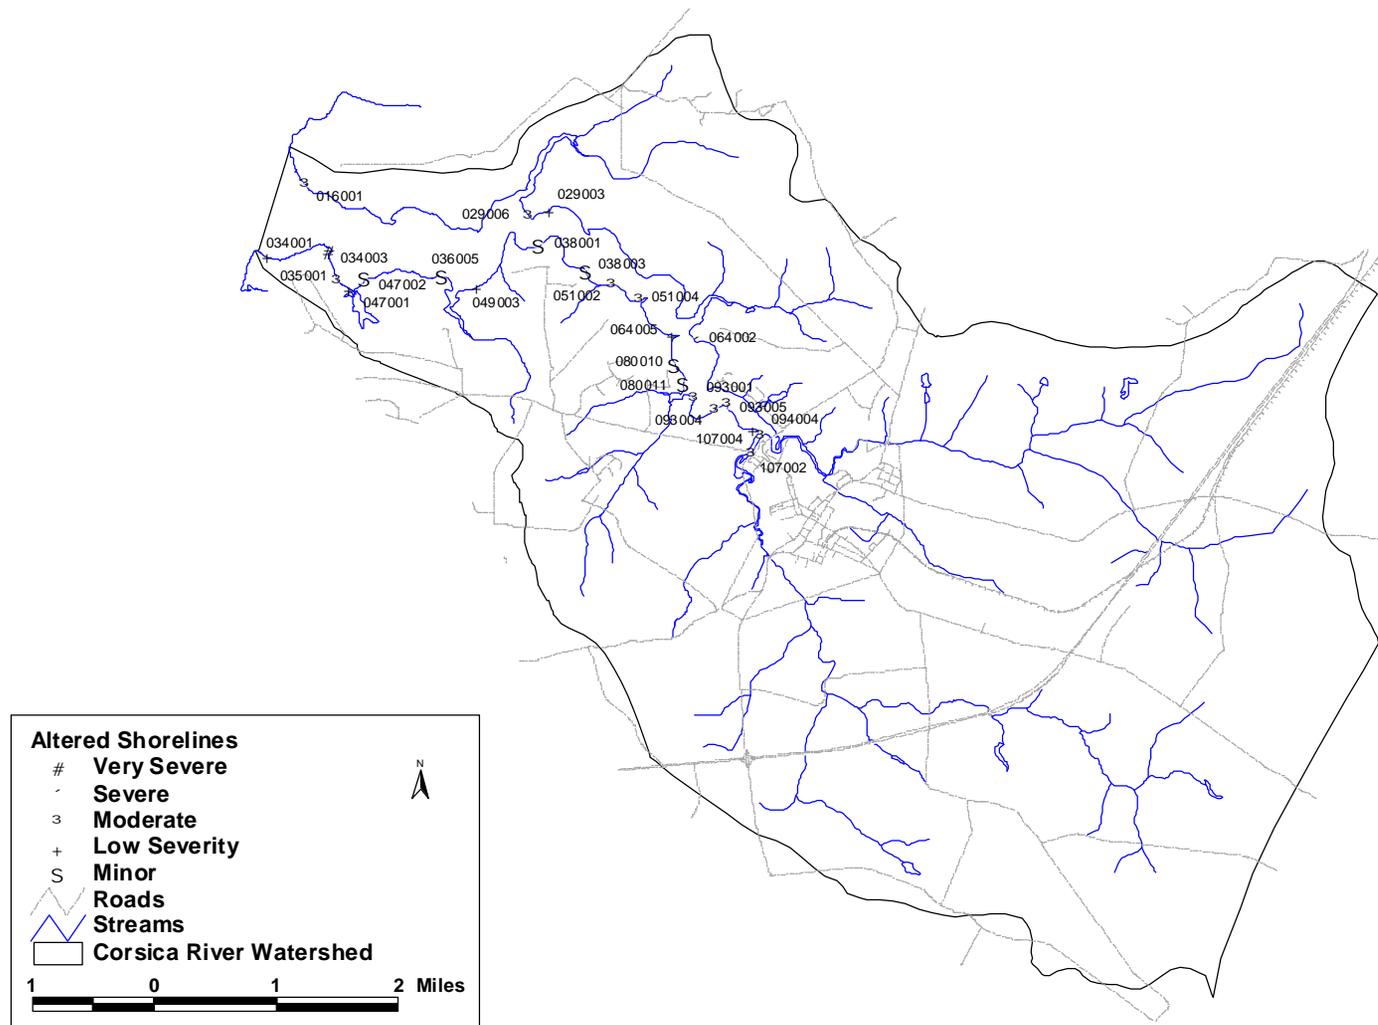
Figure 13b: Corsica River Altered Shoreline Locations.

Site 034003 is a section of broken concrete extending for 2,500ft, with a crop field above and open water below. The site is rated very severe and is located on the southern shoreline and near the mouth of the Corsica River. Site 064002 is a wood bulkhead extending for 825ft. with lawn above and open water below. The site is located on the northern shore below the Alder Branch.

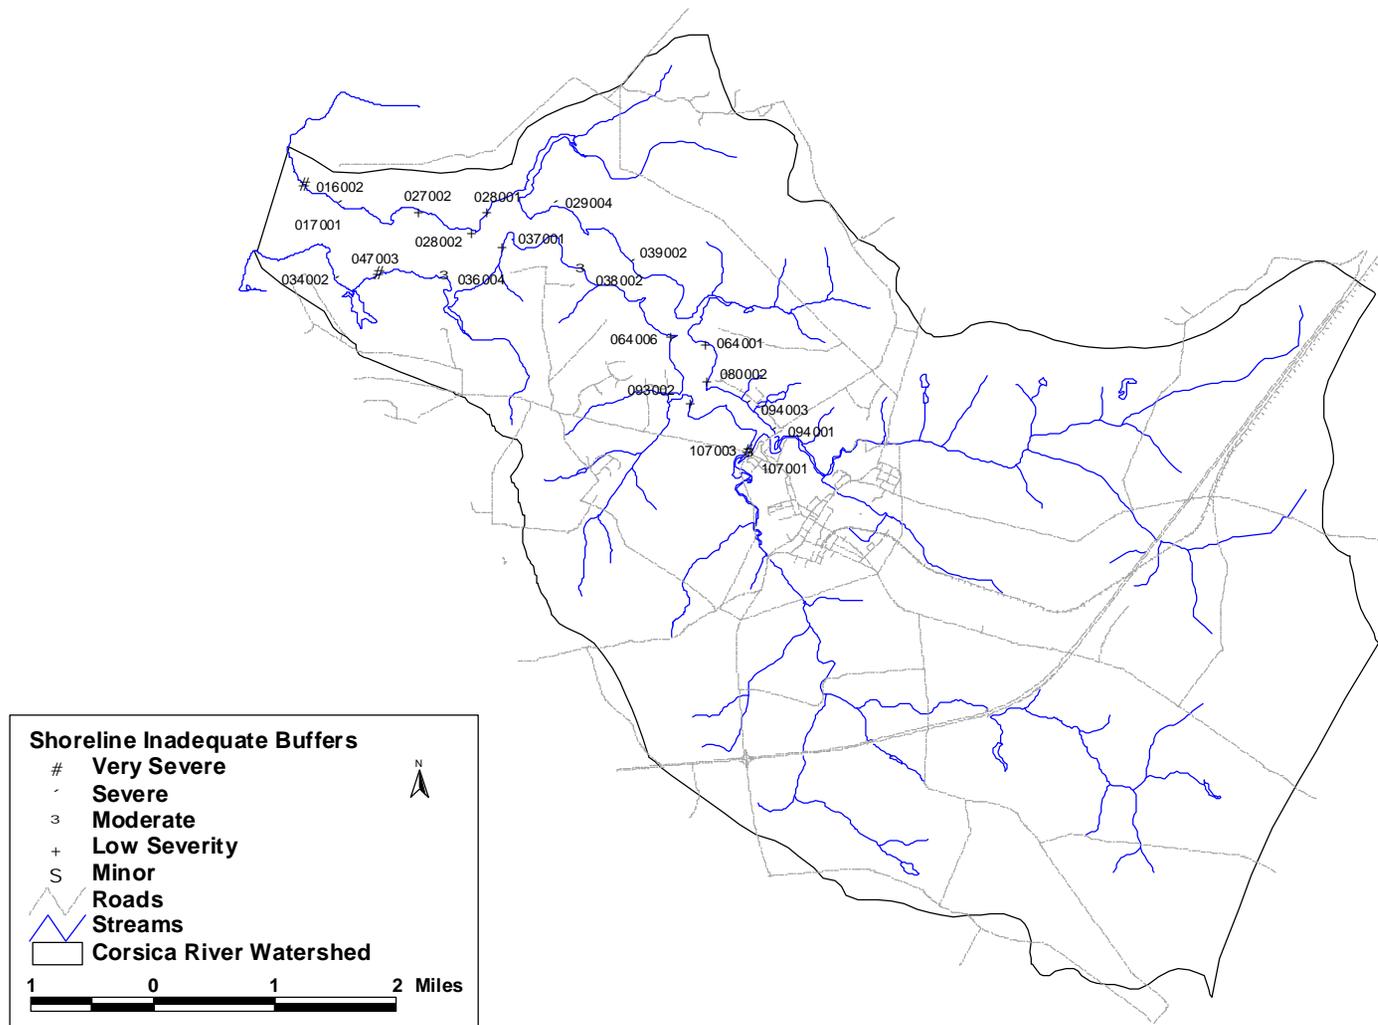
Figure 14b: Corsica River Altered Shoreline Locations.

As stated before, three sites were given very severe ratings. Site 016002 is a 1,725ft. long site with a crop field above and open water below. This site is located on the North shore at the mouth of the Corsica River. Site 047003 has no buffer extending for 2,705ft., with a residential community located above, and open water below. This site is located on the South shore at Middle Quarter Cove. Site 107003 is 1,005ft. long with shrubs and small trees above, and emergent marsh below. This site is located on the western shore of the tidal portions of Mill Stream Branch. The six sites identified as severe include: 017001, 029004, 034002, 039002, 094001, and 094003. Information on these sites can be found in Appendixes A and B.

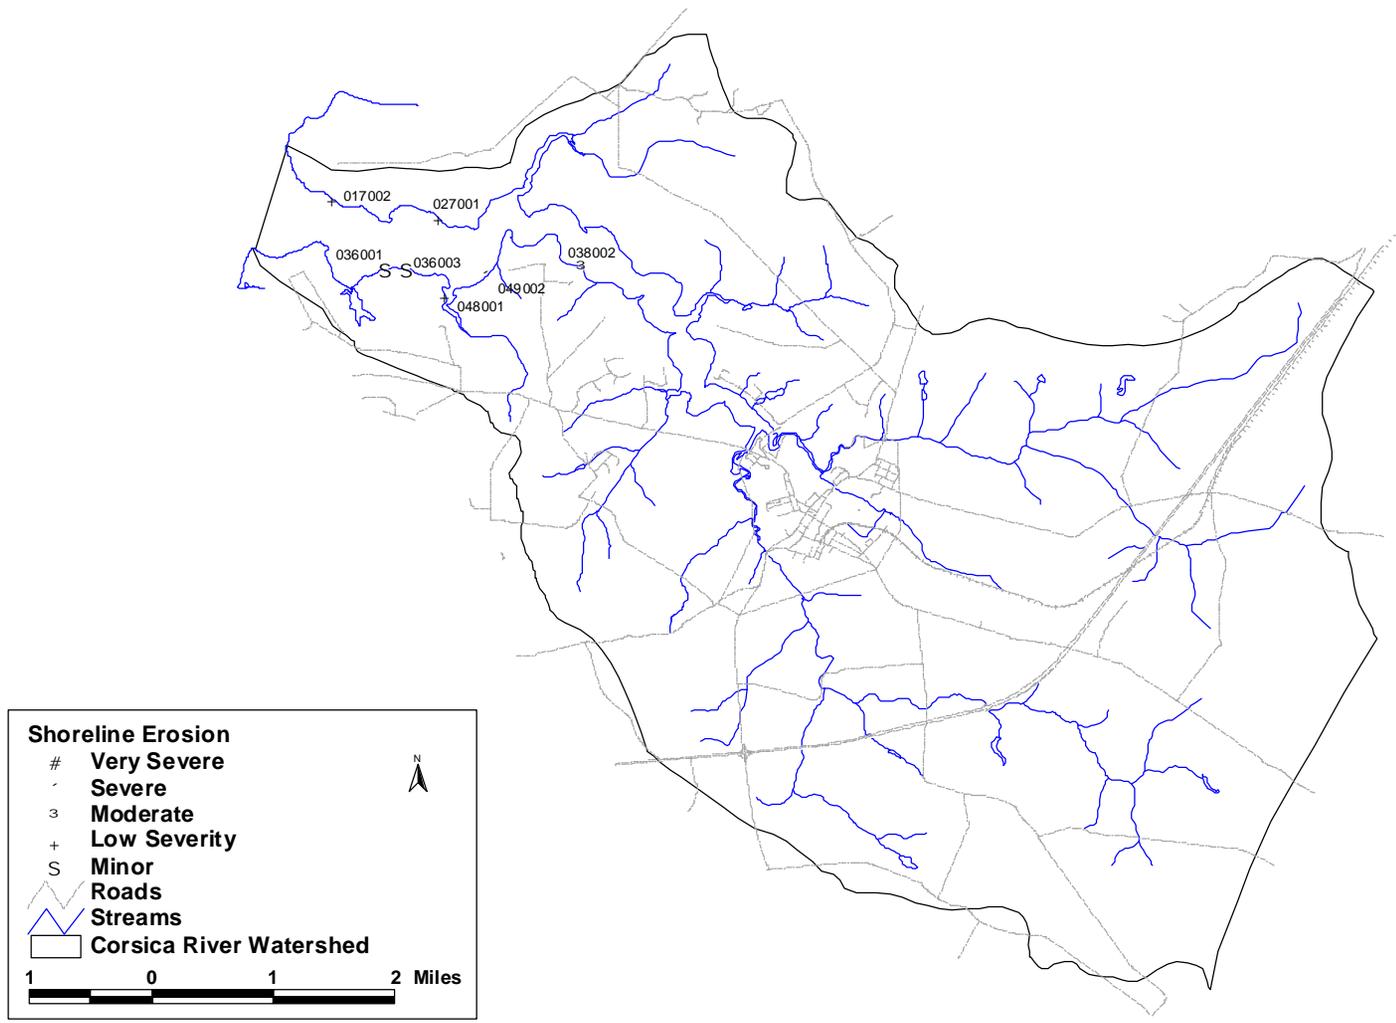
Figure 15b: Corsica River Shoreline Erosion Locations.

Seven shoreline erosion sites were identified during the Corsica River survey. The majority of these sites (5 of 7) were rated low severity to minor (Figure 15a). One site was rated severe and one moderate. Length of the erosion sites documented ranged from 125 to 1,420 feet, and height 1.5 to 15 feet. Five of the sites were located on the Northern banks of the river, and 2 on the Southern. Land use above the documented sites included: crop fields (4 sites), forest (2 sites), and lawn/shrubs & small trees/single home (1 site). Land use below included: beach (4 sites), open water (2 sites), and emergent marsh/rip-rap. Shoreline geometry of the sites were documented as straight (4 sites), cove (2 sites), and meander/irregular (1 site).

Site 049002 is a severely rated site located just upriver from Tilghman Cove on the Southern bank of the river. This site was found to be 10ft tall, 1,420 ft long with lawn, shrubs & small trees, and a single home above the site, and an emergent marsh and rip-rap below the erosion. The site is located at a meandering irregular part of the river and is posing a threat to the house located 100ft away.. It was also noted that the erosion does not look active. Site 038002 is a moderately rated 690ft long, 15ft high erosion site located on the Southern bank of the Corsica River just downstream from Miller Creek. This site was found to have forest above and open water below, and is located on a section of the river in a cove. The location of all the shoreline erosion sites can be found in Figure 15b.
