CHAP, Chapel Cove at Laurel Lakes Townhouses

**UPPER PATUXENT RIVER WATERSHED RESTORATION ACTION STRATEGY (WRAS)
FORM 1 -- Catchment Information**

UPPER PATUXENT RIVER WATERSHED RESTORATION ACTION STRATEGY (WRAS) FORM 2 -- Site Information

UPPER PATUXENT RIVER WATERSHED RESTORATION ACTION STRATEGY (WRAS) FORM 3 -- Opportunities and Constraints of Potential Management Practice

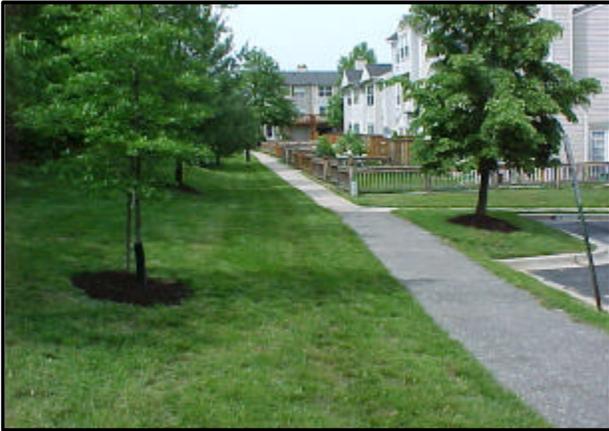
- No. 890 Description: looking north along west side of site
- No. 891 Description: looking east along South Shore Drive
- No. 892 Description: looking north along Chapel Cove Court
- No. 893 Description: looking west along South Shore Drive
- No. 894 Description: looking west along Chapel Cove Drive
- No. 895 Description: looking west along north side of property
- No. 896 Description: typical backyards
- No. 897 Description: typical front yard
- No. 898 Description: typical front view
- No. 899 Description: typical back view

Comments Little room for rain barrels, cisterns or planter box in front. Parking space appears to be at a premium.

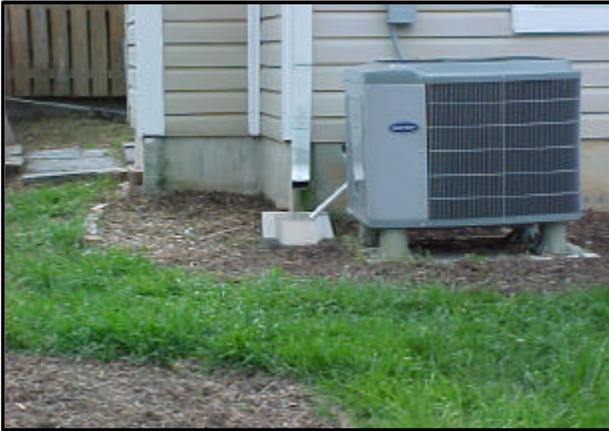
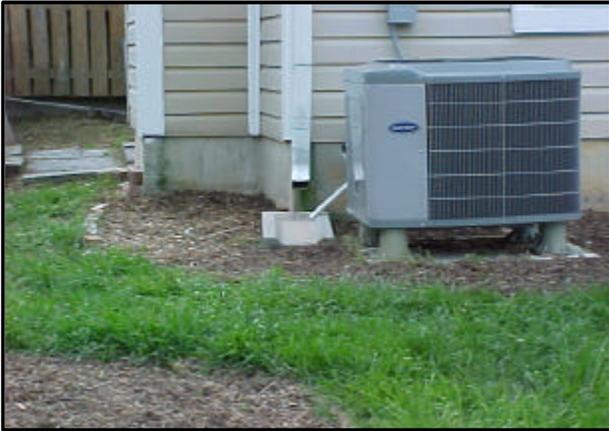
900

No.	<u>900</u>	Description:	<u>typical downspout discharge</u>
No.	<u>905</u>	Description:	<u>typical constrained downspout discharge</u>
No.	_____	Description:	_____
No.	_____	Description:	_____
No.	_____	Description:	_____
No.	_____	Description:	_____
No.	_____	Description:	_____
No.	_____	Description:	_____

Comments Rain barrels/cisterns, as well as planters boxes, will be installed as space allows.

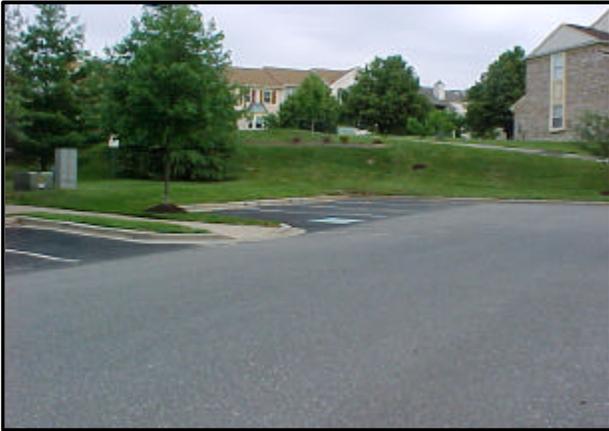
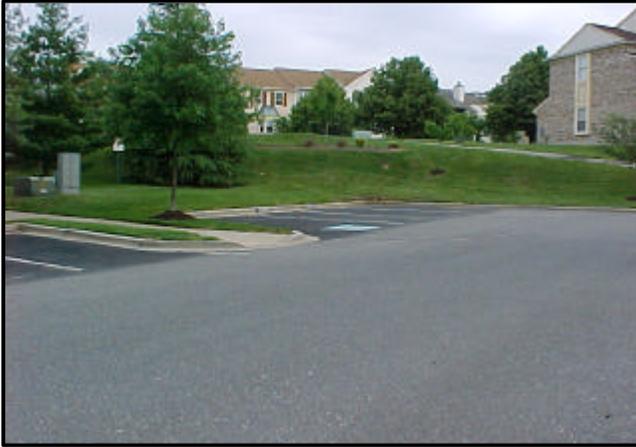
910

No.	<u>910</u>	Description:	<u>site a, looking southeast</u>
No.	<u>911</u>	Description:	<u>site b, looking south</u>
No.	<u>912</u>	Description:	<u>site c, looking south</u>
No.	<u> </u>	Description:	<u> </u>
No.	<u> </u>	Description:	<u> </u>
No.	<u> </u>	Description:	<u> </u>
No.	<u> </u>	Description:	<u> </u>
No.	<u> </u>	Description:	<u> </u>

IMP size = 22,650 sq ft

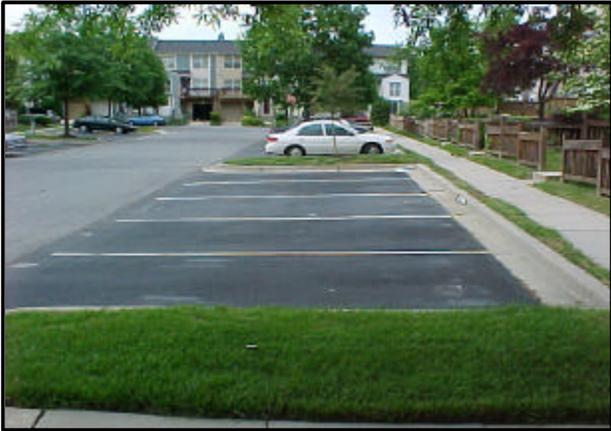
901

No. <u>901</u>	Description: <u>typical parking area</u>
No. _____	Description: _____

IMP size = 33,975 sq ft

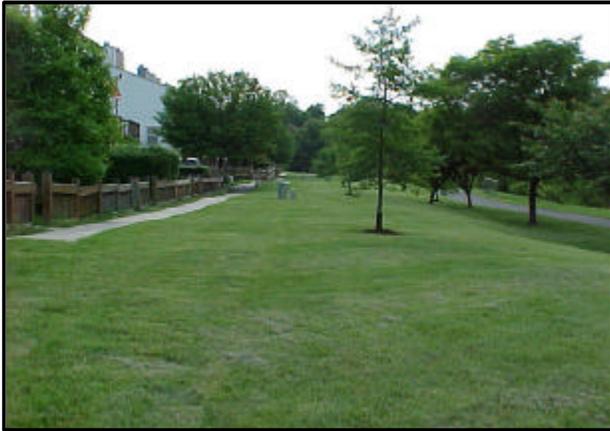
913

No. <u>916</u>	Description: <u>looking east from dead end</u>
No. <u>913</u>	Description: <u>looking west</u>
No. <u>914</u>	Description: <u>looking west from Chapel Cove Court</u>
No. <u>915</u>	Description: <u>looking east from Chapel Cove Court</u>
No. _____	Description: _____

IMP size = 11,831 sq ft
