**UPPER PATUXENT RIVER WATERSHED RESTORATION ACTION STRATEGY (WRAS)  
FORM 1 -- Catchment Information**

## UPPER PATUXENT RIVER WATERSHED RESTORATION ACTION STRATEGY (WRAS) FORM 2 -- Site Information

Site Name: Scotch Town Hills Elementary School Address: 15950 Dorset Road, Laurel MD, 20707  
 Site Owner: Board of Education  
 State Plane Coordinates of Site Centroid: X: 1346846 Y: 525196 Date: 3/12/03  
 Personnel: PM, ZJL Weather: overcast 55F deg  
 Area (ac): 7.4 Impervious Area (ac): 3.7  
 Percent Impervious: 50% Soil Recharge Factor (S): 0.13  
 WQ<sub>v</sub> (required): 0.31 Re<sub>v</sub> (required): 0.04  
 Property Area (ac): 10.4 Property Area Included in Site: 71 %  
 Amount of Catchment Occupied by Site: 100 %

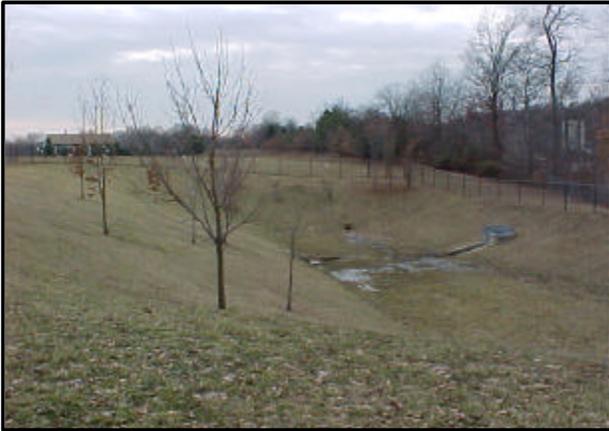
- No. 321 Description: looking northwest towards SWM pond
- No. 322 Description: looking southwest towards parking lot
- No. 323 Description: looking east along north side of school
- No. 324 Description: looking south along west side of school
- No. 325 Description: looking east along west side of school
- No. 326 Description: looking east along south side of school
- No. 327 Description: looking north along east side of school
- No. \_\_\_\_\_ Description: \_\_\_\_\_
- No. \_\_\_\_\_ Description: \_\_\_\_\_
- No. \_\_\_\_\_ Description: \_\_\_\_\_
