Corsica River Stream Corridor Assessment And Shoreline Surveys

Watershed Assessment and Targeting Division
Watershed Services Unit
Maryland Department of Natural Resources
August 2004

CORSICA RIVER STREAM CORRIDOR ASSESSMENT AND SHORELINE SURVEYS

Stephen Czwartacki, Ken Yetman & Anne Patterson
Watershed Assessment and Targeting Division
Watershed Services Unit
Maryland Department of Natural Resources

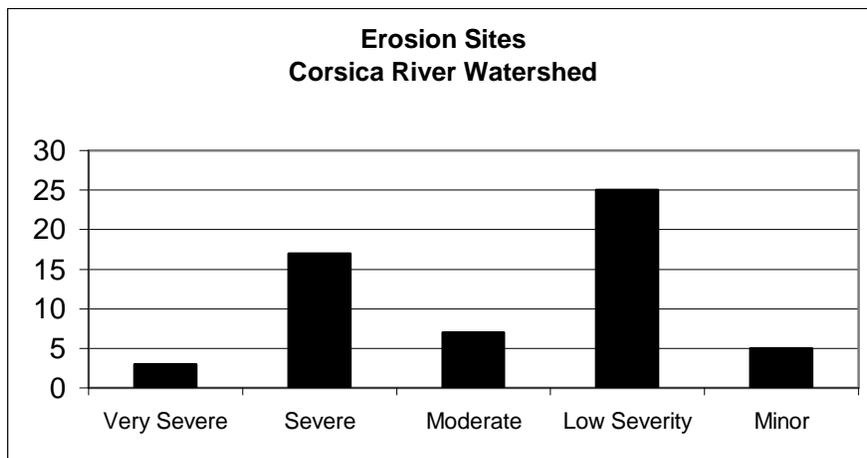
Figure 4a. Histogram showing the frequency of severity ratings given to erosion sites during the Corsica River SCA survey.

The SCA survey found 57 eroding stream banks over the length of 64,312 feet (12.18 miles) of stream, or about 26% of streams surveyed. The severity and location of erosion sites is shown in Figure 4b. Three sites are ranked as very severe, 17 as of severe, 7 as moderate, 25 as low severity, and 5 as minor (Figure 4a). Length of these sites varies from 15 to 7,230 feet. Heights of the stream banks at erosion sites in the Corsica River watershed vary from 1 to 12 feet (Appendix B).

Three sites were found to be very severe. Site 021103 is on the south tributary to Emory Creek, and was identified as widening erosion site. The erosion problem extends for 1,037 feet, average bank height was 4 feet, and is surrounded by forest. Site 138202 is located on the south fork of the Three Bridges Branch, and is possibly being caused by an altered channel upstream. This site stretches for 7,230 feet, with average stream bank height of 4 feet and is surrounded by forest. Site 160102 is on the headwaters of Gravel Run and is found below a railroad crossing. This site is 3,430ft. long with 4 feet high banks and a crop field on the right and forest on the left. Seventeen additional sites were identified as severe (Figure 4a) and information on them is presented in Appendix A & B.

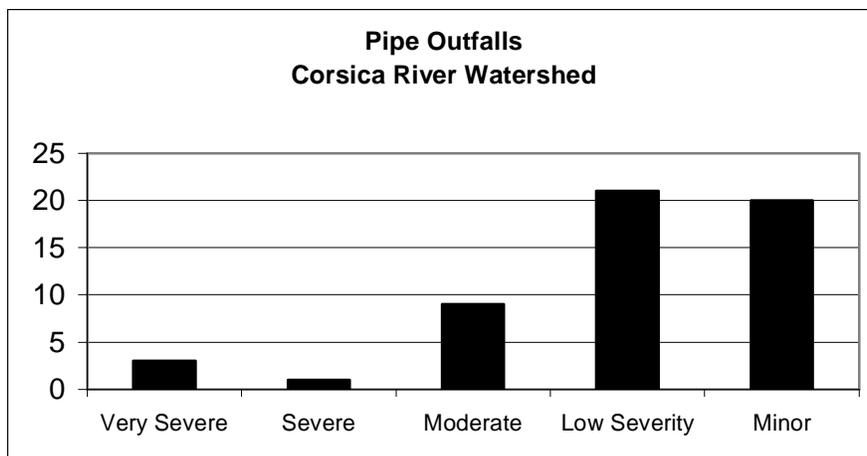
Figure 5a. Histogram showing the frequency of severity ratings given to pipe outfalls during the Corsica River SCA survey.

Three pipes were rated very severe and one severe. Site 096211 is a very severely rated plastic 6in. pipe on the right bank of a tributary of Three Bridges Branch. This pipe has created a channel 2ft. wide, and has a medium brown discharge. The purpose for the pipe is unknown. Site 121104 is a 12-inch smooth metal sewage overflow pipe on the left bank of Gravel Run. Although no discharge was observed the field crew did see debris caught under the clapper valve and believed that the pipe could have recently discharged. The pipe outfall was given a very severe rating. Site 121106 is an 18 inch 4 feet long corrugated metal stormwater pipe located on the left bank of Gravel Run. A medium brown musky smelling discharged was observed, and the site was given a very severe rating. Site 121110 is a 4-inch pipe with a medium brown discharge on Gravel Run. This site was given a severe rating.

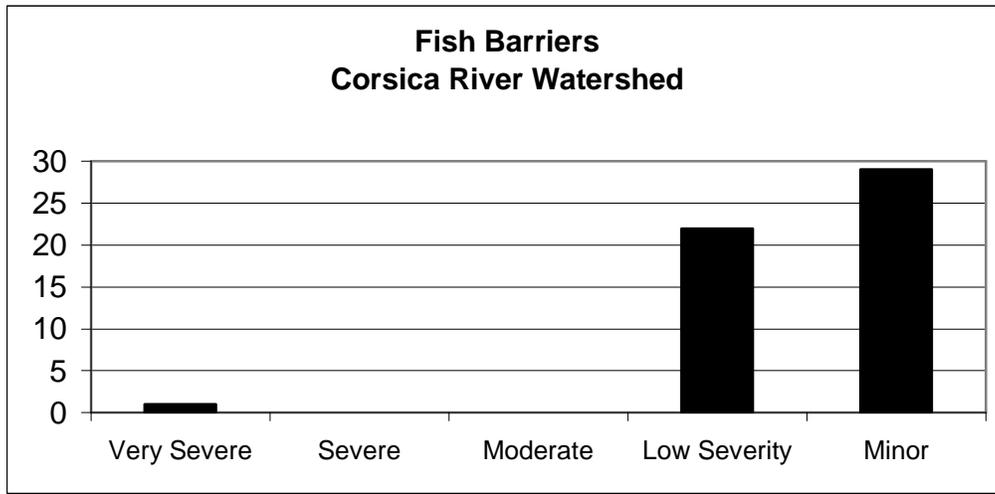
Figure 6a. Histogram showing the frequency of severity ratings given to fish barriers during the Corsica River SCA survey.

The Corsica River SCA survey found 52 fish migration barriers. The locations of fish blockages are shown in Figure 6a. Fish barriers in these watersheds are due to natural falls (24 sites), road crossings (11 sites), beaver dams (5 sites), pipe crossings (3 sites), channelized streams (1 site), and a dam. The majority of fish migration barriers (51 out of 52) are low to minor in severity (Figure 6a). These sites were given low severity rankings because they are either temporary blockages, or they isolate only a short section of stream. Site 121122 is a dam on Gravel Run with a drop of 60in. at the extent of the tidal area. This dam may impede the movement of anadromous fish in the tributary. This site is located on public land and is a potential fish passage project site.

In all cases, areas should be assessed for viable fish habitat before restoration work begins, giving preference to sites with the most potential habitat area created.

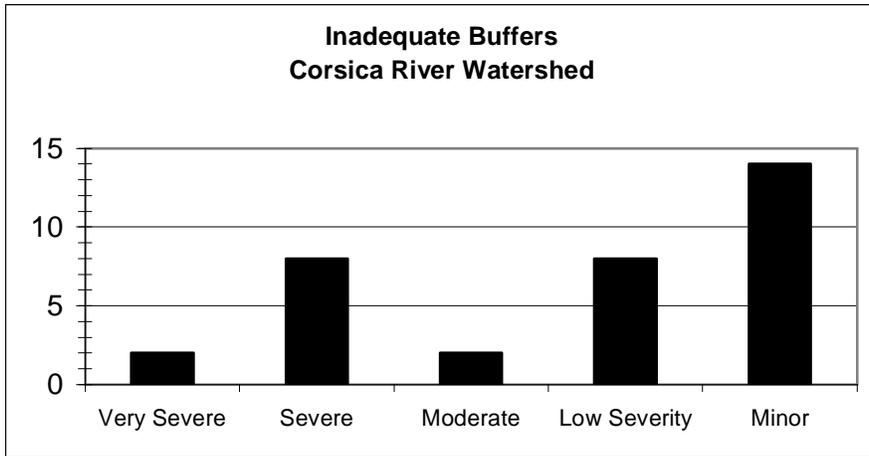
Figure 7a. Histogram showing the frequency of severity ratings given to inadequate buffers during the Corsica River SCA survey.

Survey crews identified 34 inadequate buffer sites with a total length of 20,915ft. (3.96 miles), or approximately 8% of streams surveyed. The severity and location of inadequate buffer sites is shown in Figure 7a. Twenty-four of these sites are ranked as moderate to minor severity, while the other ten sites are very severe and severe (Figure 7b). Lengths of inadequately buffered streams ranged from 70ft. to 2,165ft. Six of the 34 sites did not have a forest buffer on either side of the stream. Land use along the stream at inadequate buffer sites is recorded for both sides of the stream; therefore the land use amounts will be double the site amounts. Examples of land use for the sides of streams are as follows: cropland (39 sites), forest (9 sites), lawn (9 sites), pasture (5 sites), shrubs and small trees (4 sites), railroad tracks (1 site), and a construction site (1 site). Site 085103 had a recent buffer planting along the stream on a tributary of Three Bridges Branch. Crews reported that horses had access to the stream at site 215102.

Site 128101 is a very severe site with no buffer width stretching for 1,615ft. through a crop field on the headwaters of Three Bridges Branch. Site 193103 is also a very severe site with no buffer width for 1,575ft. through a crop field on the headwaters of Mill Stream Branch. Eight sites were given severe ratings and include: Sites 156201, 199203, 217201, and 229201 on Mill Stream Branch; Sites 117201, and 130102 on Earle Creek; Site 090102 on Middle Quarter Creek; and Site 149205 on Three Bridges Branch.

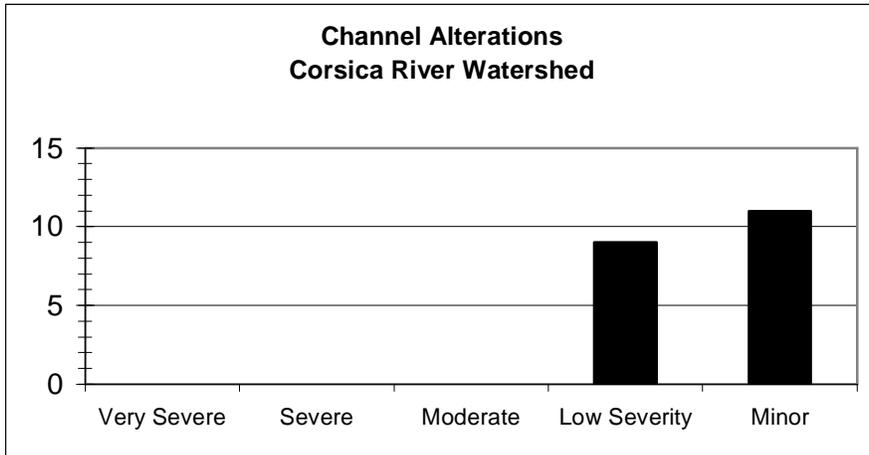
Figure 8a. Histogram showing the frequency of severity ratings given to channel alterations during the Corsica River SCA survey.

Results of this survey show recognizably altered stream channels at 20 sites. The severity and location of channel alteration sites is shown in Figure 8a. The total length of stream affected by channelization is estimated to be 6,185 feet (1.17 miles), or 2.41% of streams surveyed. All channel alteration sites were ranked low (9 sites) to minor (11 sites) in severity. The majority of sites (11 sites) were documented as earth channels. Also found were concrete channels (4 sites), rip-rap (2 sites), corrugated pipe (1 site), gabion baskets (1 site), and a metal pipe channel. Eight sites were found at road crossings. Bottom width ranged from 1.5ft. to 12ft., and length of the sites ranged from 5ft. to 1,000ft.

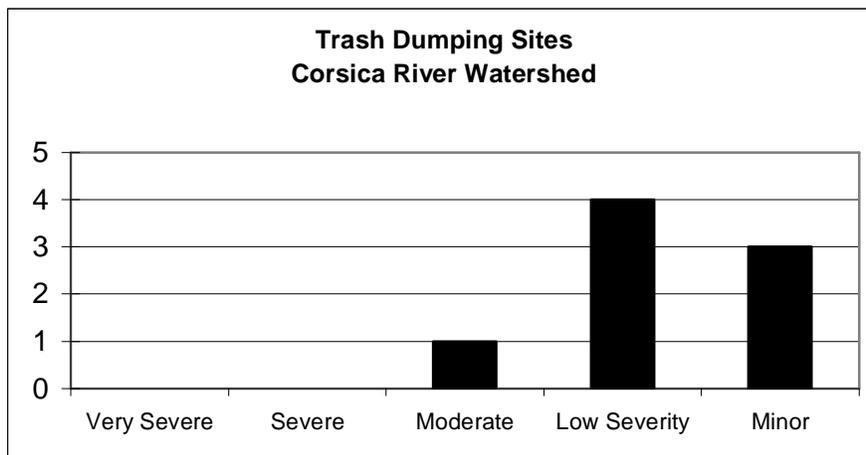
Figure 9a. Histogram showing the frequency of severity ratings given to trash dumping sites during the Corsica River SCA survey.

Survey crews found 8 trash dumping sites (Figure 9a). This is a very low number of sites compared to other watersheds previously surveyed throughout Maryland. In terms of severity rating, 1 sites were ranked as moderate, 4 were given a low severity rating, and 3 were considered minor (Figure 9b). Two sites contained residential waste, 3 sites had construction materials and lumber, 1 site had industrial material, 1 site had tires and one site was characterized as junkyard of cars and buses. The one moderate site (144106) consisted of a junkyard of cars and buses over a larger area within the stream corridor behind a residence on Mill Stream Branch. Site 096202 at a construction site on Three Bridges Branch, was the only other site considered a large area. All other sites were located at confined sites, and 5 sites, 096202, 099102, 105203, 118102, and 147103 are potential sites for volunteer clean-up projects. Ownership of lands containing the trash dumping sites were either private (5 sites) or unknown (3 sites).

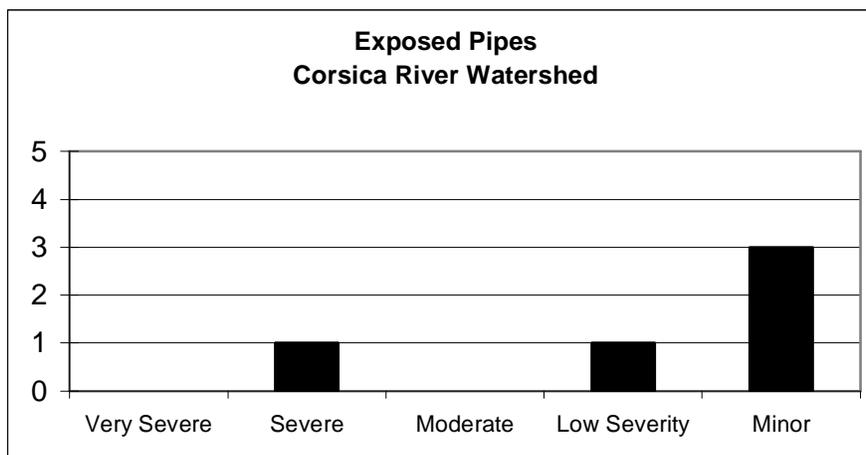
Figure 10a. Histogram showing the frequency of severity ratings given to exposed pipes during the Corsica River SCA survey.

Field crews observed 5 exposed pipes during the survey. One of these sites received a severe rating while the others were given low severity (1 site) or minor (3 site) ratings (Figure 10a). Figure 10b shows the location of these sites. Two pipes were exposed across the bottom of the stream, 2 were exposed along the stream bank, and 1 pipe was exposed below a bridge. Three pipes were documented as smooth metal pipes, 1 as a plastic pipe, and 1 as a concrete sewage pipe. Pipe diameters ranged from 2 to 36 inches, and the lengths of the exposed pipes ranged from 8 to 300 feet. None of the observed pipes had a discharge, and all but one sewage pipe were unknown in origin. Site 121108 is the only severe pipe to be documented. This site is a pipe 36in. in diameter concrete sewage pipe exposed across the bottom of the stream below the Rte. 213 bridge on Gravel Run. Follow-up visits could be made to the sites to further evaluate their severities and a means for repairing or replacing the pipes.

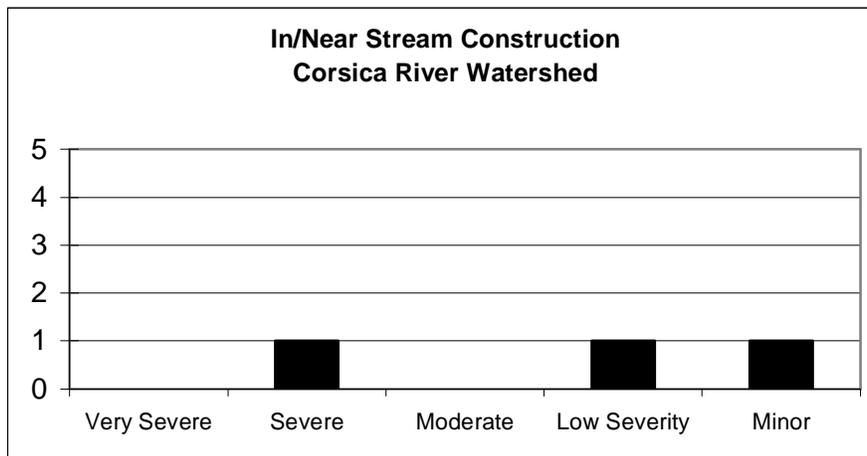
Figure 11a. Histogram showing the frequency of severity ratings given to in/near stream construction sites during the Corsica River SCA survey.

Most sites were given a low to minor severity rating (Figure 11a). One site (096101) was given a severe rating. The site is located at a new residential development site at the head of a tributary on Three Bridges Branch. Field crews reported what appeared to be excess sediment in the stream channel downstream of the new development. The town of Centreville was notified about this site shortly after it was observed.

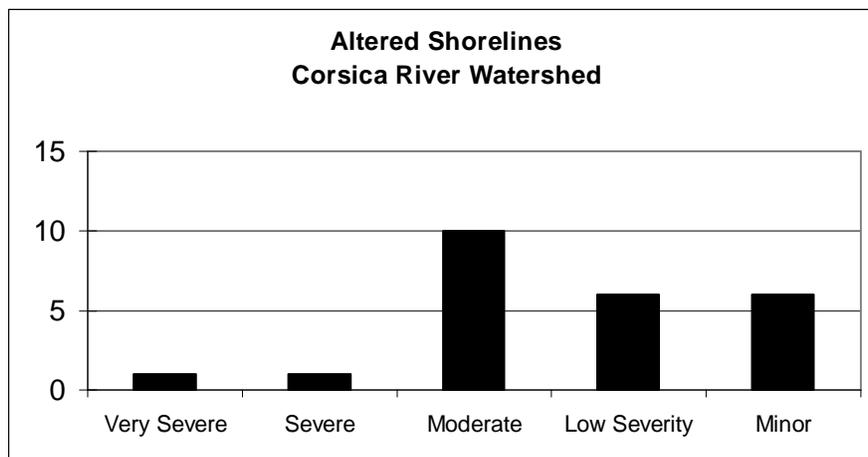
Figure 13a. Histogram showing the frequency of severity ratings given to altered shoreline sites during the Corsica River Tidal SCA survey.

Twenty-four altered shoreline sites were documented during the tidal survey. Altered shorelines are anywhere in the tidal area of a river where the bank of the river has been armored in order to protect it from erosion. Erosion can occur when shorelines are inadequately buffered, therefore altered shorelines being used to fix erosion problem sites are commonly found around inadequately buffered areas. Fourteen of twenty-four altered shoreline sites (58%) were documented at sites where inadequate buffers were found. The total amount of altered shorelines found adds up to 2.47 miles, or 9.89%, of the shoreline of the Corsica River. The majority of altered shoreline sites were rated to be moderate to minor in severity, but one was found to be very severe and one severe (Figure 13a). The location of the Corsica River's altered shoreline sites can be found in Figure 13b.

Site 034003 is a section of broken concrete extending for 2,500ft, with a crop field above and open water below. The site is rated very severe and is located on the southern shoreline and near the mouth of the Corsica River. Site 064002 is a wood bulkhead extending for 825ft. with lawn above and open water below. The site is located on the northern shore below the Alder Branch.

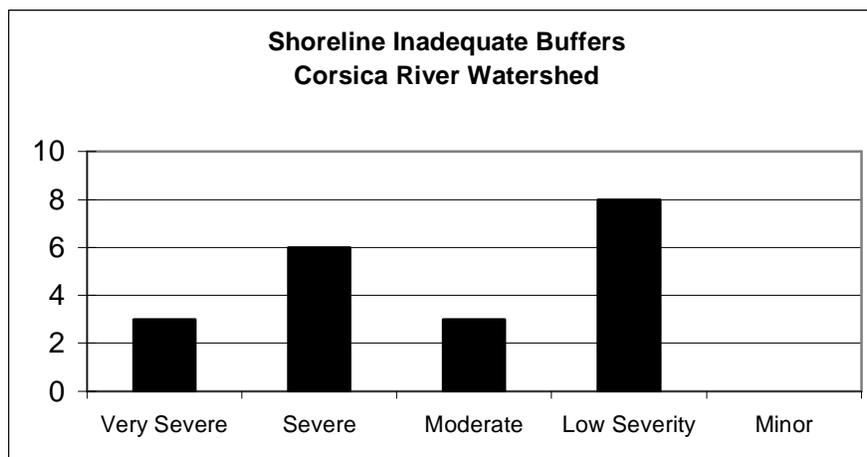
Figure 14a. Histogram showing the frequency of severity ratings given to inadequate buffer sites during the Corsica River Tidal SCA survey.

Shoreline inadequate buffer sites are considered inadequate in this survey when the forest buffer does not extend more than 50ft. beyond the bank of the tidal river. Forest buffers along the banks of tidal areas of a river greatly reduce erosion of a shoreline. Twenty inadequate buffer sites were identified along the banks of the tidal portion of the Corsica River. These sites total 24,705ft. (4.67 miles), and make up about 19% of the Corsica's total shoreline. The majority of sites identified by the survey were given severe to low severity ratings, as seen in Figure 14a. Three sites were given very severe ratings. The locations of the Shoreline Inadequate Buffers are shown in Figure 14b.

As stated before, three sites were given very severe ratings. Site 016002 is a 1,725ft. long site with a crop field above and open water below. This site is located on the North shore at the mouth of the Corsica River. Site 047003 has no buffer extending for 2,705ft., with a residential community located above, and open water below. This site is located on the South shore at Middle Quarter Cove. Site 107003 is 1,005ft. long with shrubs and small trees above, and emergent marsh below. This site is located on the western shore of the tidal portions of Mill Stream Branch. The six sites identified as severe include: 017001, 029004, 034002, 039002, 094001, and 094003. Information on these sites can be found in Appendixes A and B.

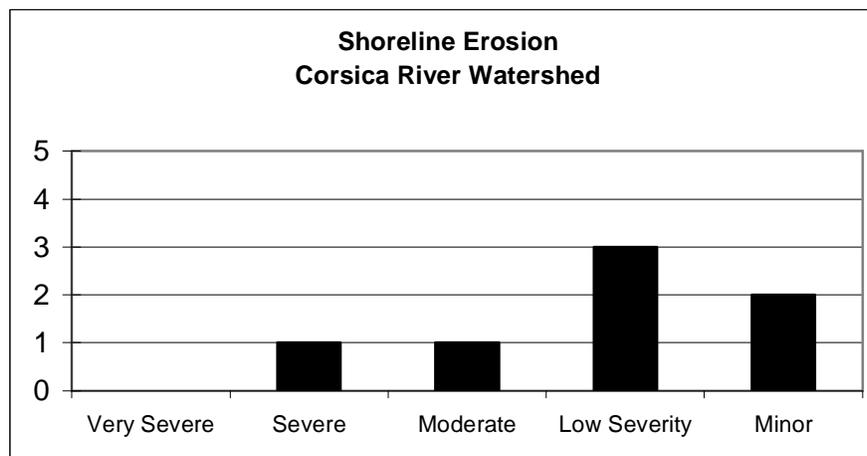
Figure 15a. Histogram showing the frequency of severity ratings given to shoreline erosion sites during the Corsica River Tidal SCA survey.

Seven shoreline erosion sites were identified during the Corsica River survey. The majority of these sites (5 of 7) were rated low severity to minor (Figure 15a). One site was rated severe and one moderate. Length of the erosion sites documented ranged from 125 to 1,420 feet, and height 1.5 to 15 feet. Five of the sites were located on the Northern banks of the river, and 2 on the Southern. Land use above the documented sites included: crop fields (4 sites), forest (2 sites), and lawn/shrubs & small trees/single home (1 site). Land use below included: beach (4 sites), open water (2 sites), and emergent marsh/rip-rap. Shoreline geometry of the sites were documented as straight (4 sites), cove (2 sites), and meander/irregular (1 site).

Site 049002 is a severely rated site located just upriver from Tilghman Cove on the Southern bank of the river. This site was found to be 10ft tall, 1,420 ft long with lawn, shrubs & small trees, and a single home above the site, and an emergent marsh and rip-rap below the erosion. The site is located at a meandering irregular part of the river and is posing a threat to the house located 100ft away.. It was also noted that the erosion does not look active. Site 038002 is a moderately rated 690ft long, 15ft high erosion site located on the Southern bank of the Corsica River just downstream from Miller Creek. This site was found to have forest above and open water below, and is located on a section of the river in a cove. The location of all the shoreline erosion sites can be found in Figure 15b.
